# **Community Grants Program Final Report**

General Information		
Grant Program	Community Infrastructure - Stormwater and Water Quality (CI-18-01)	
Contract Number	HD-9018	
Grant Organization	Camp Fire Angeles	
Date Submitted

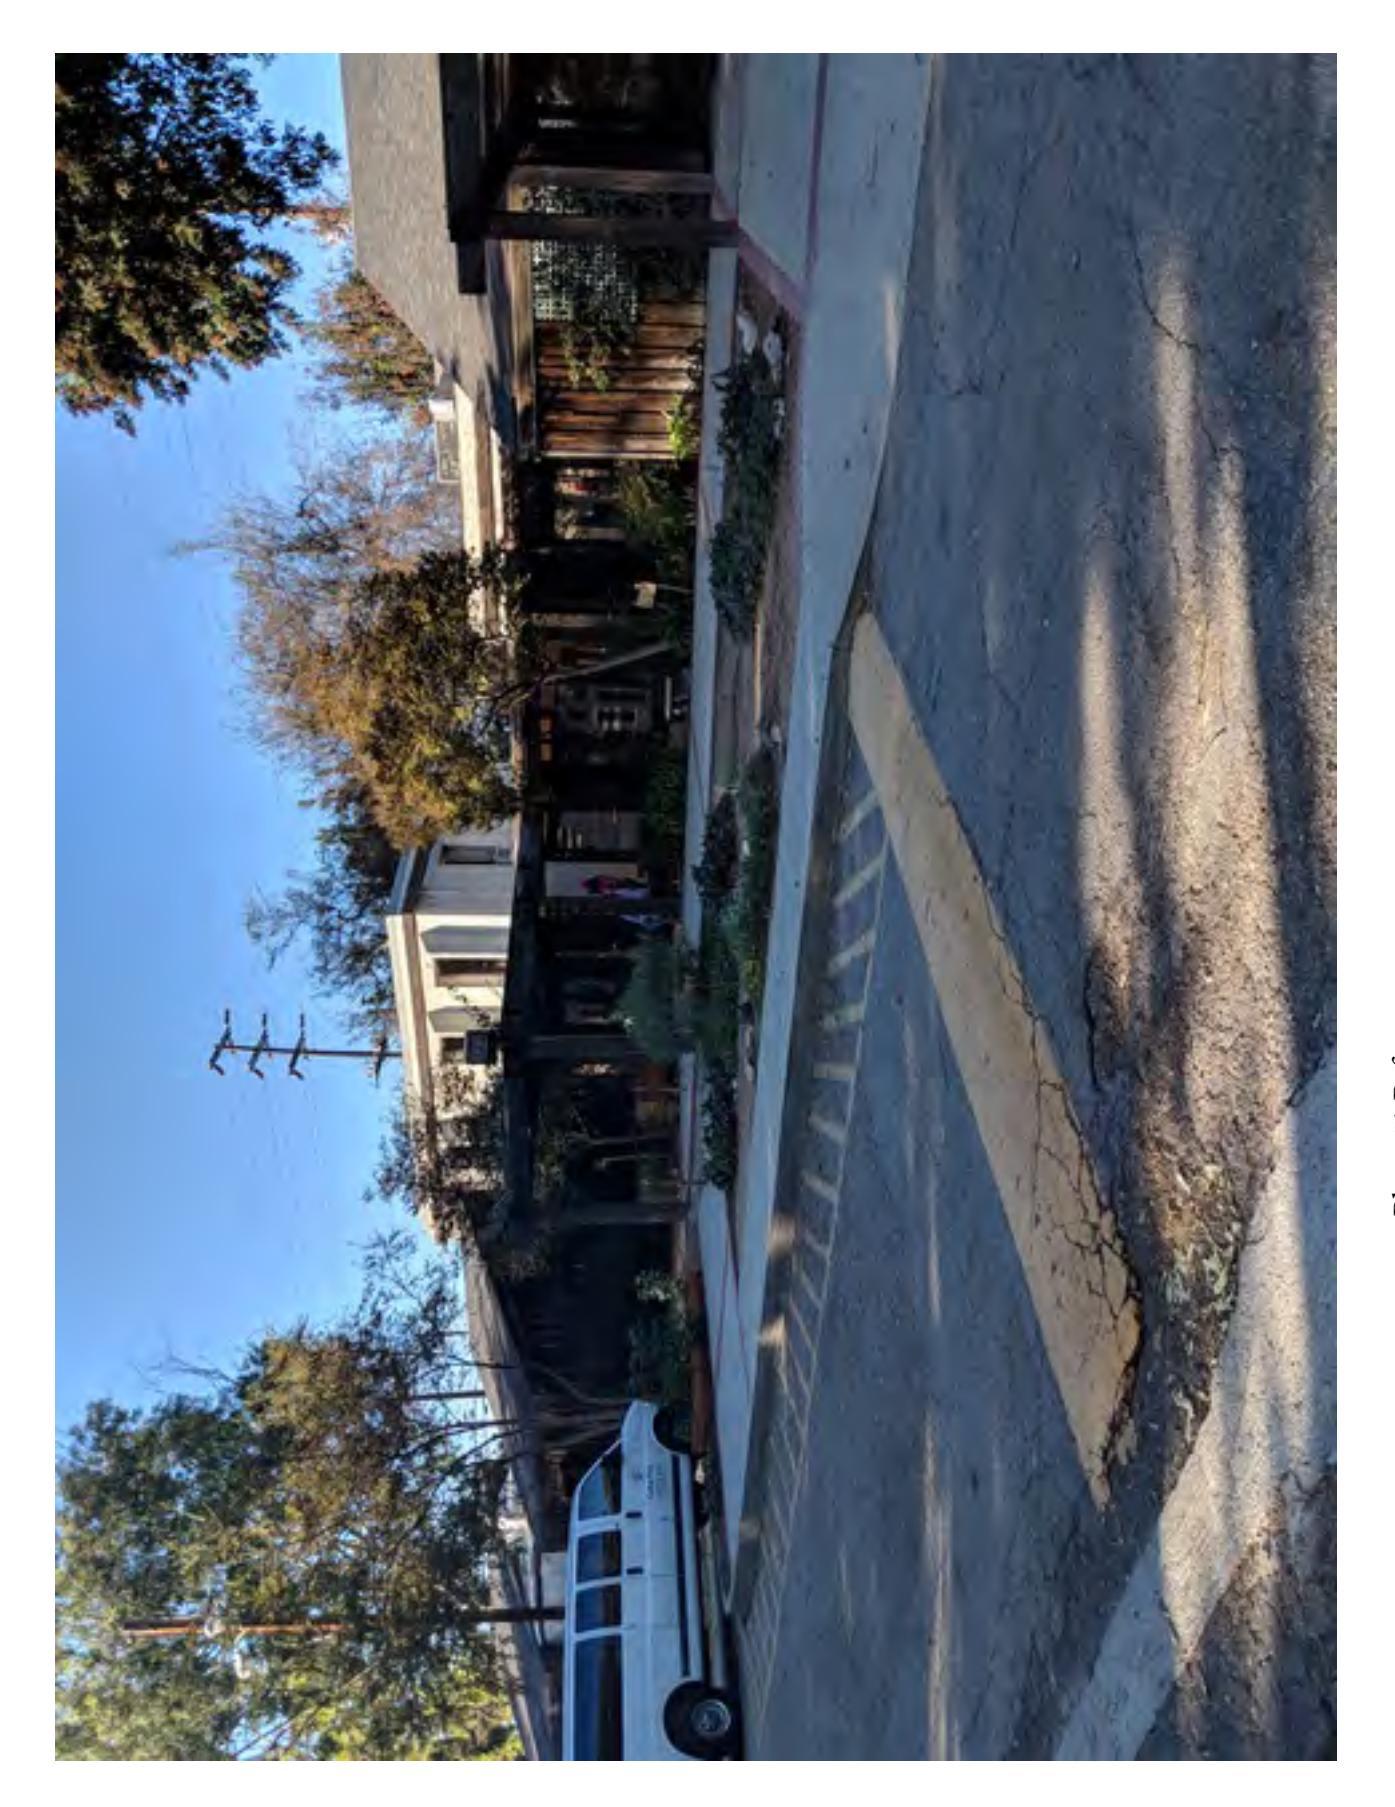
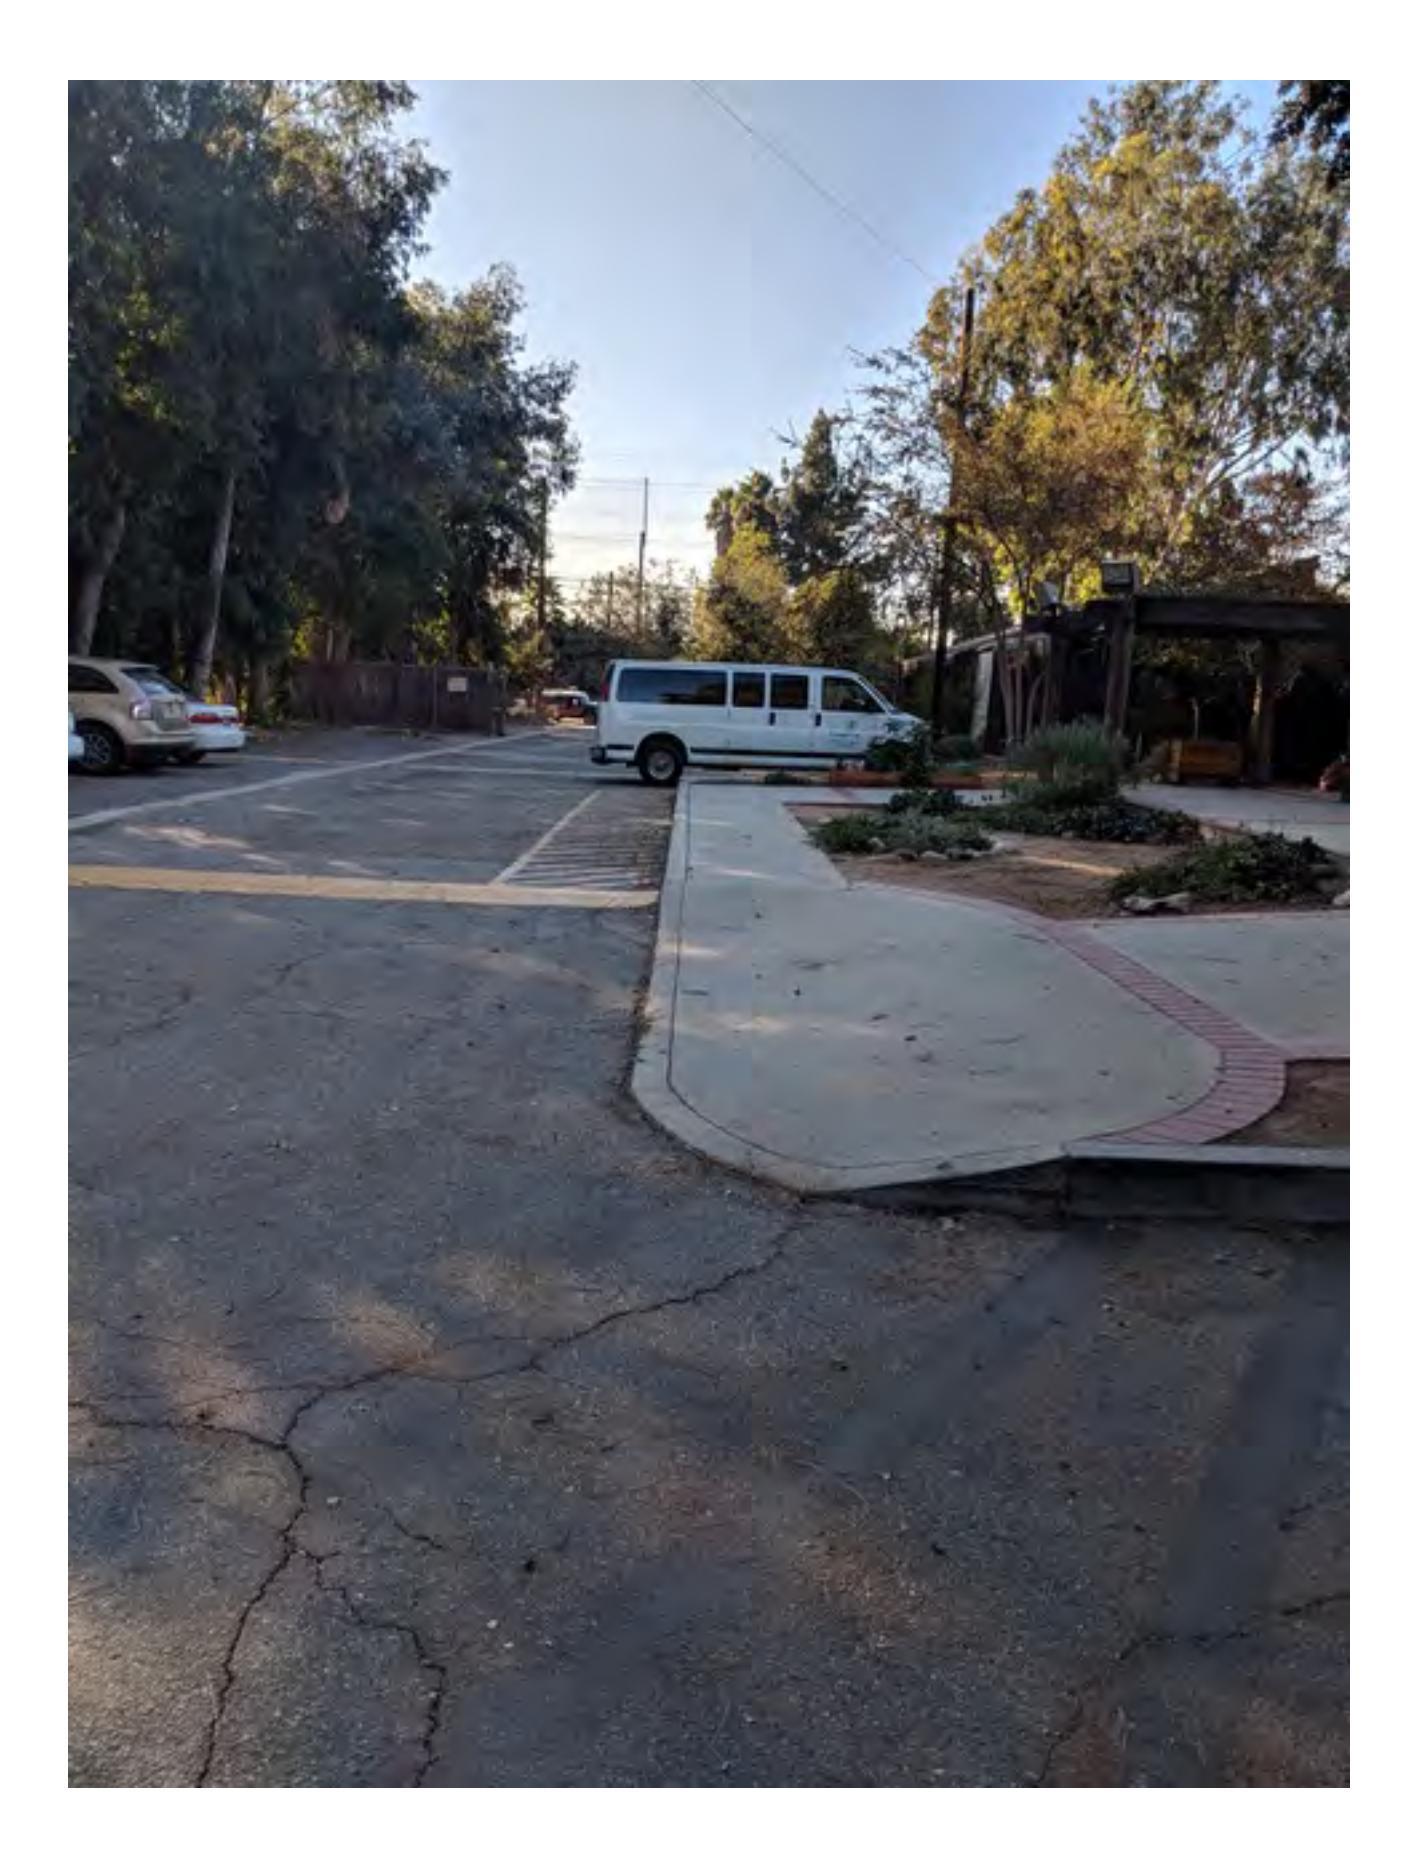
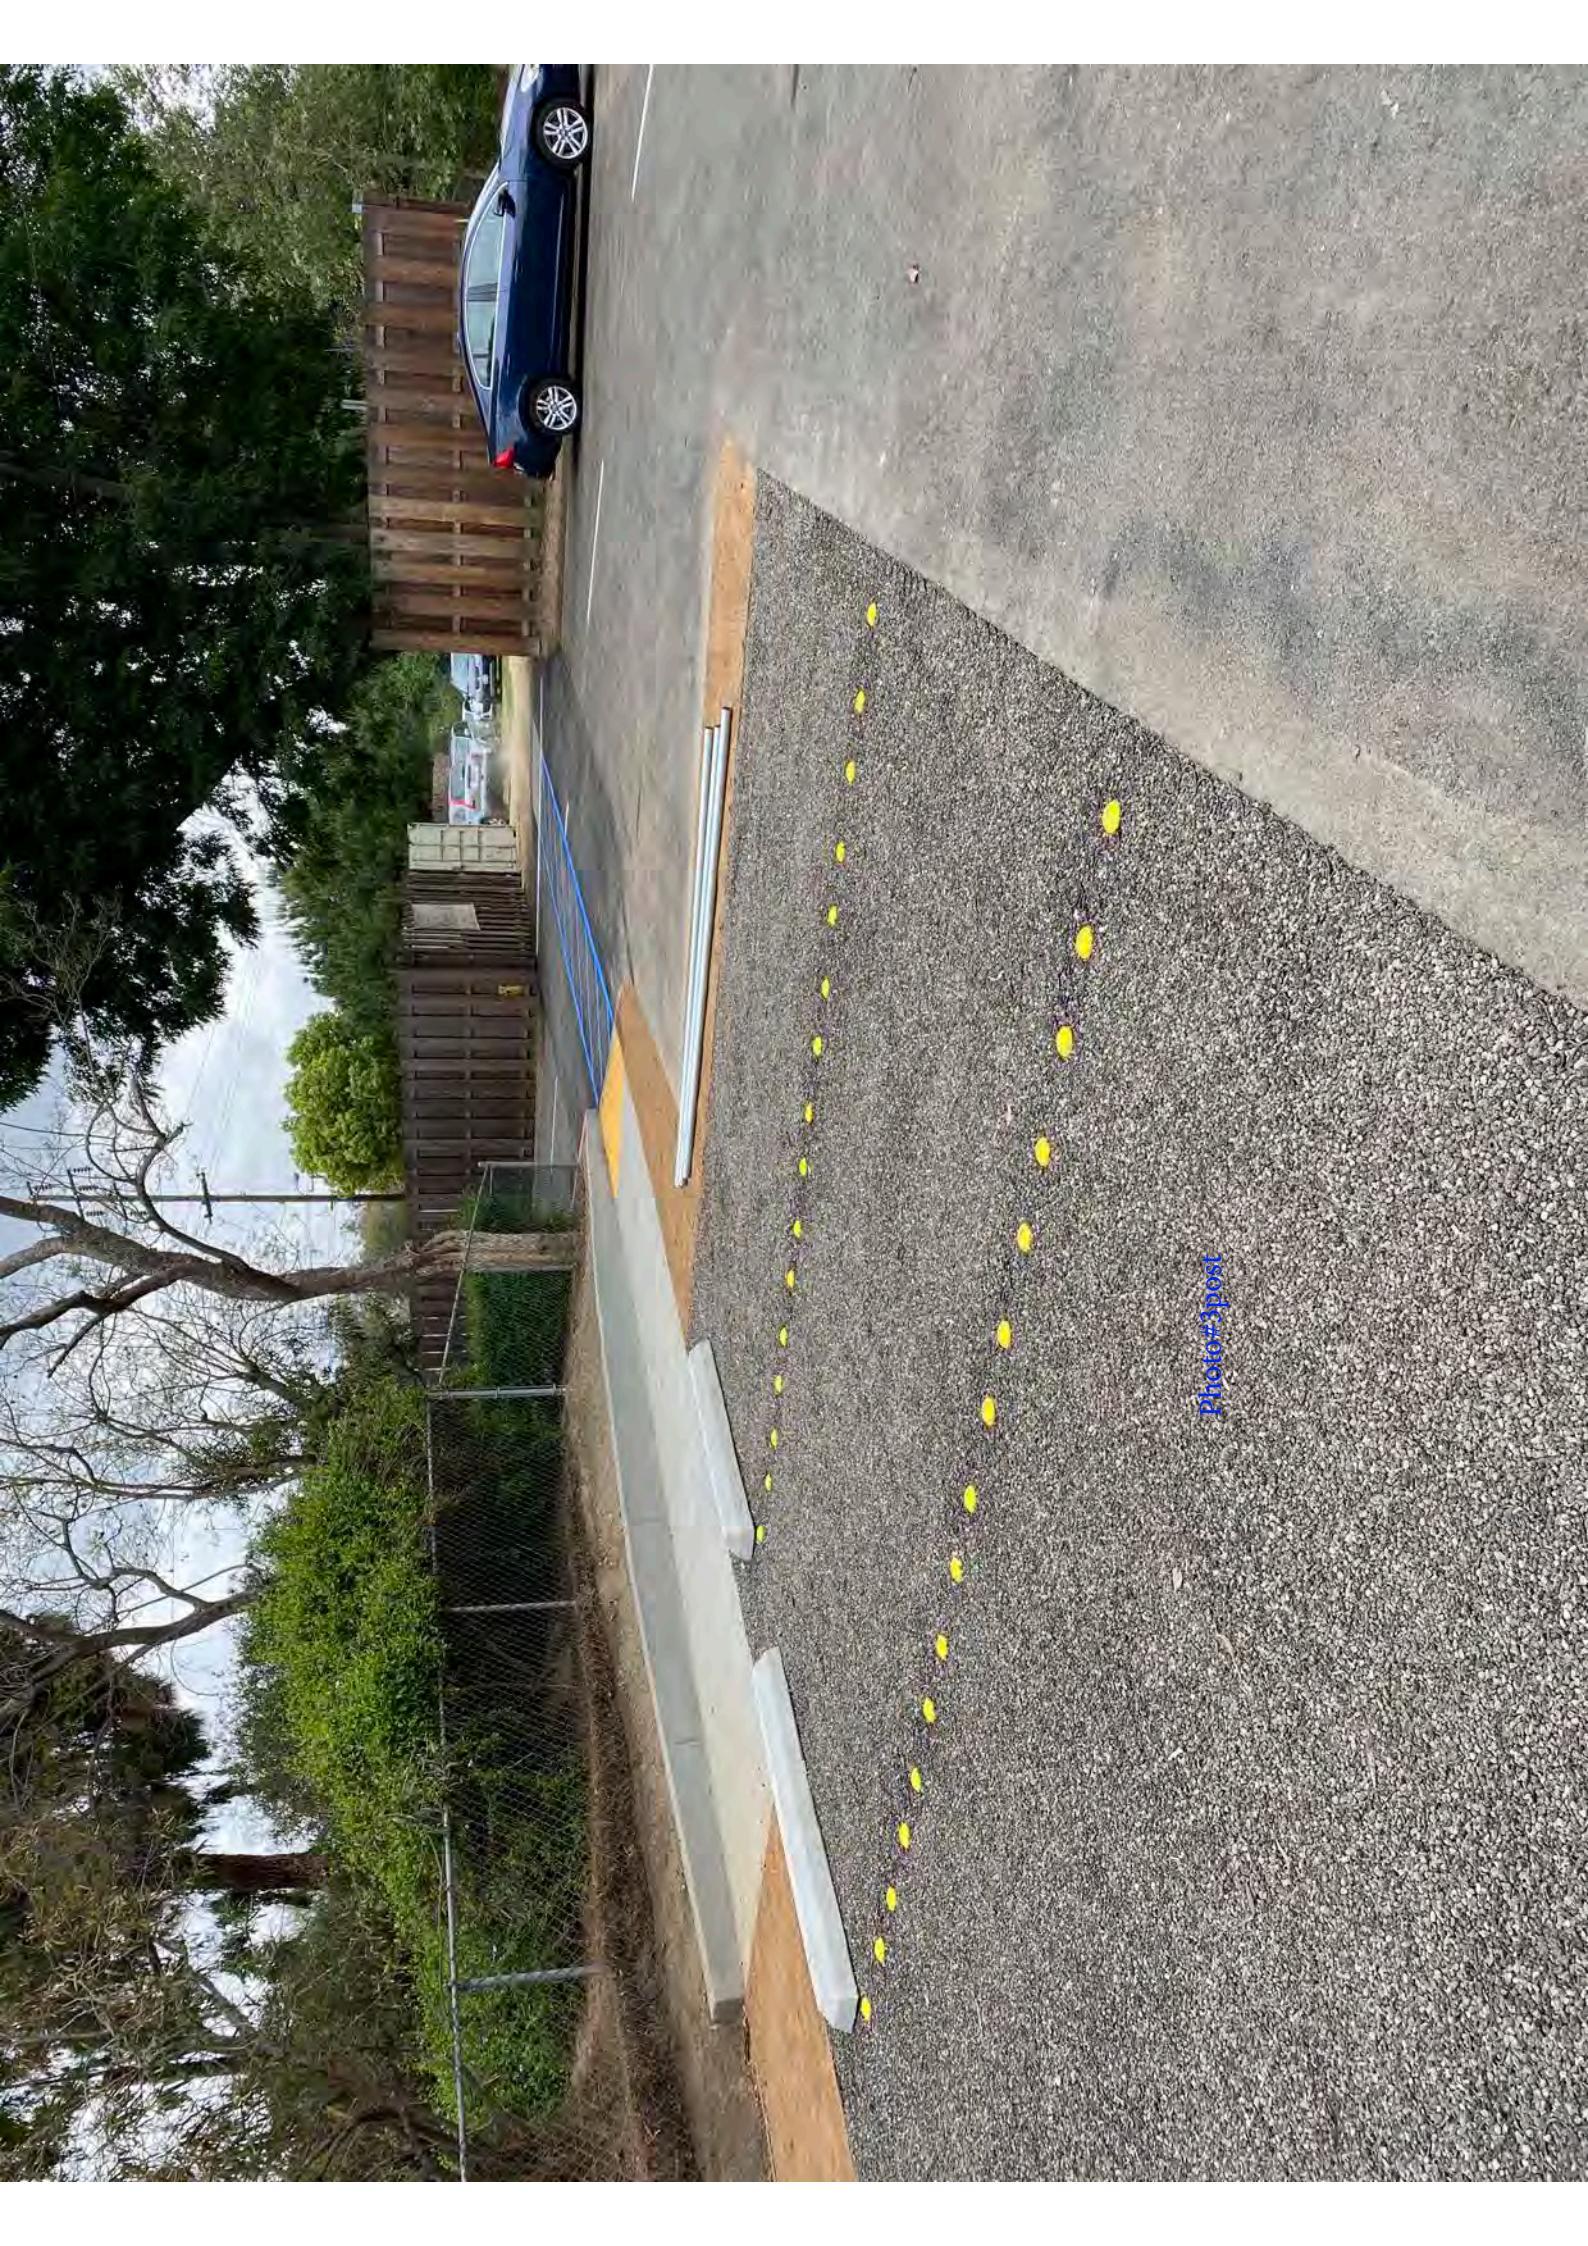
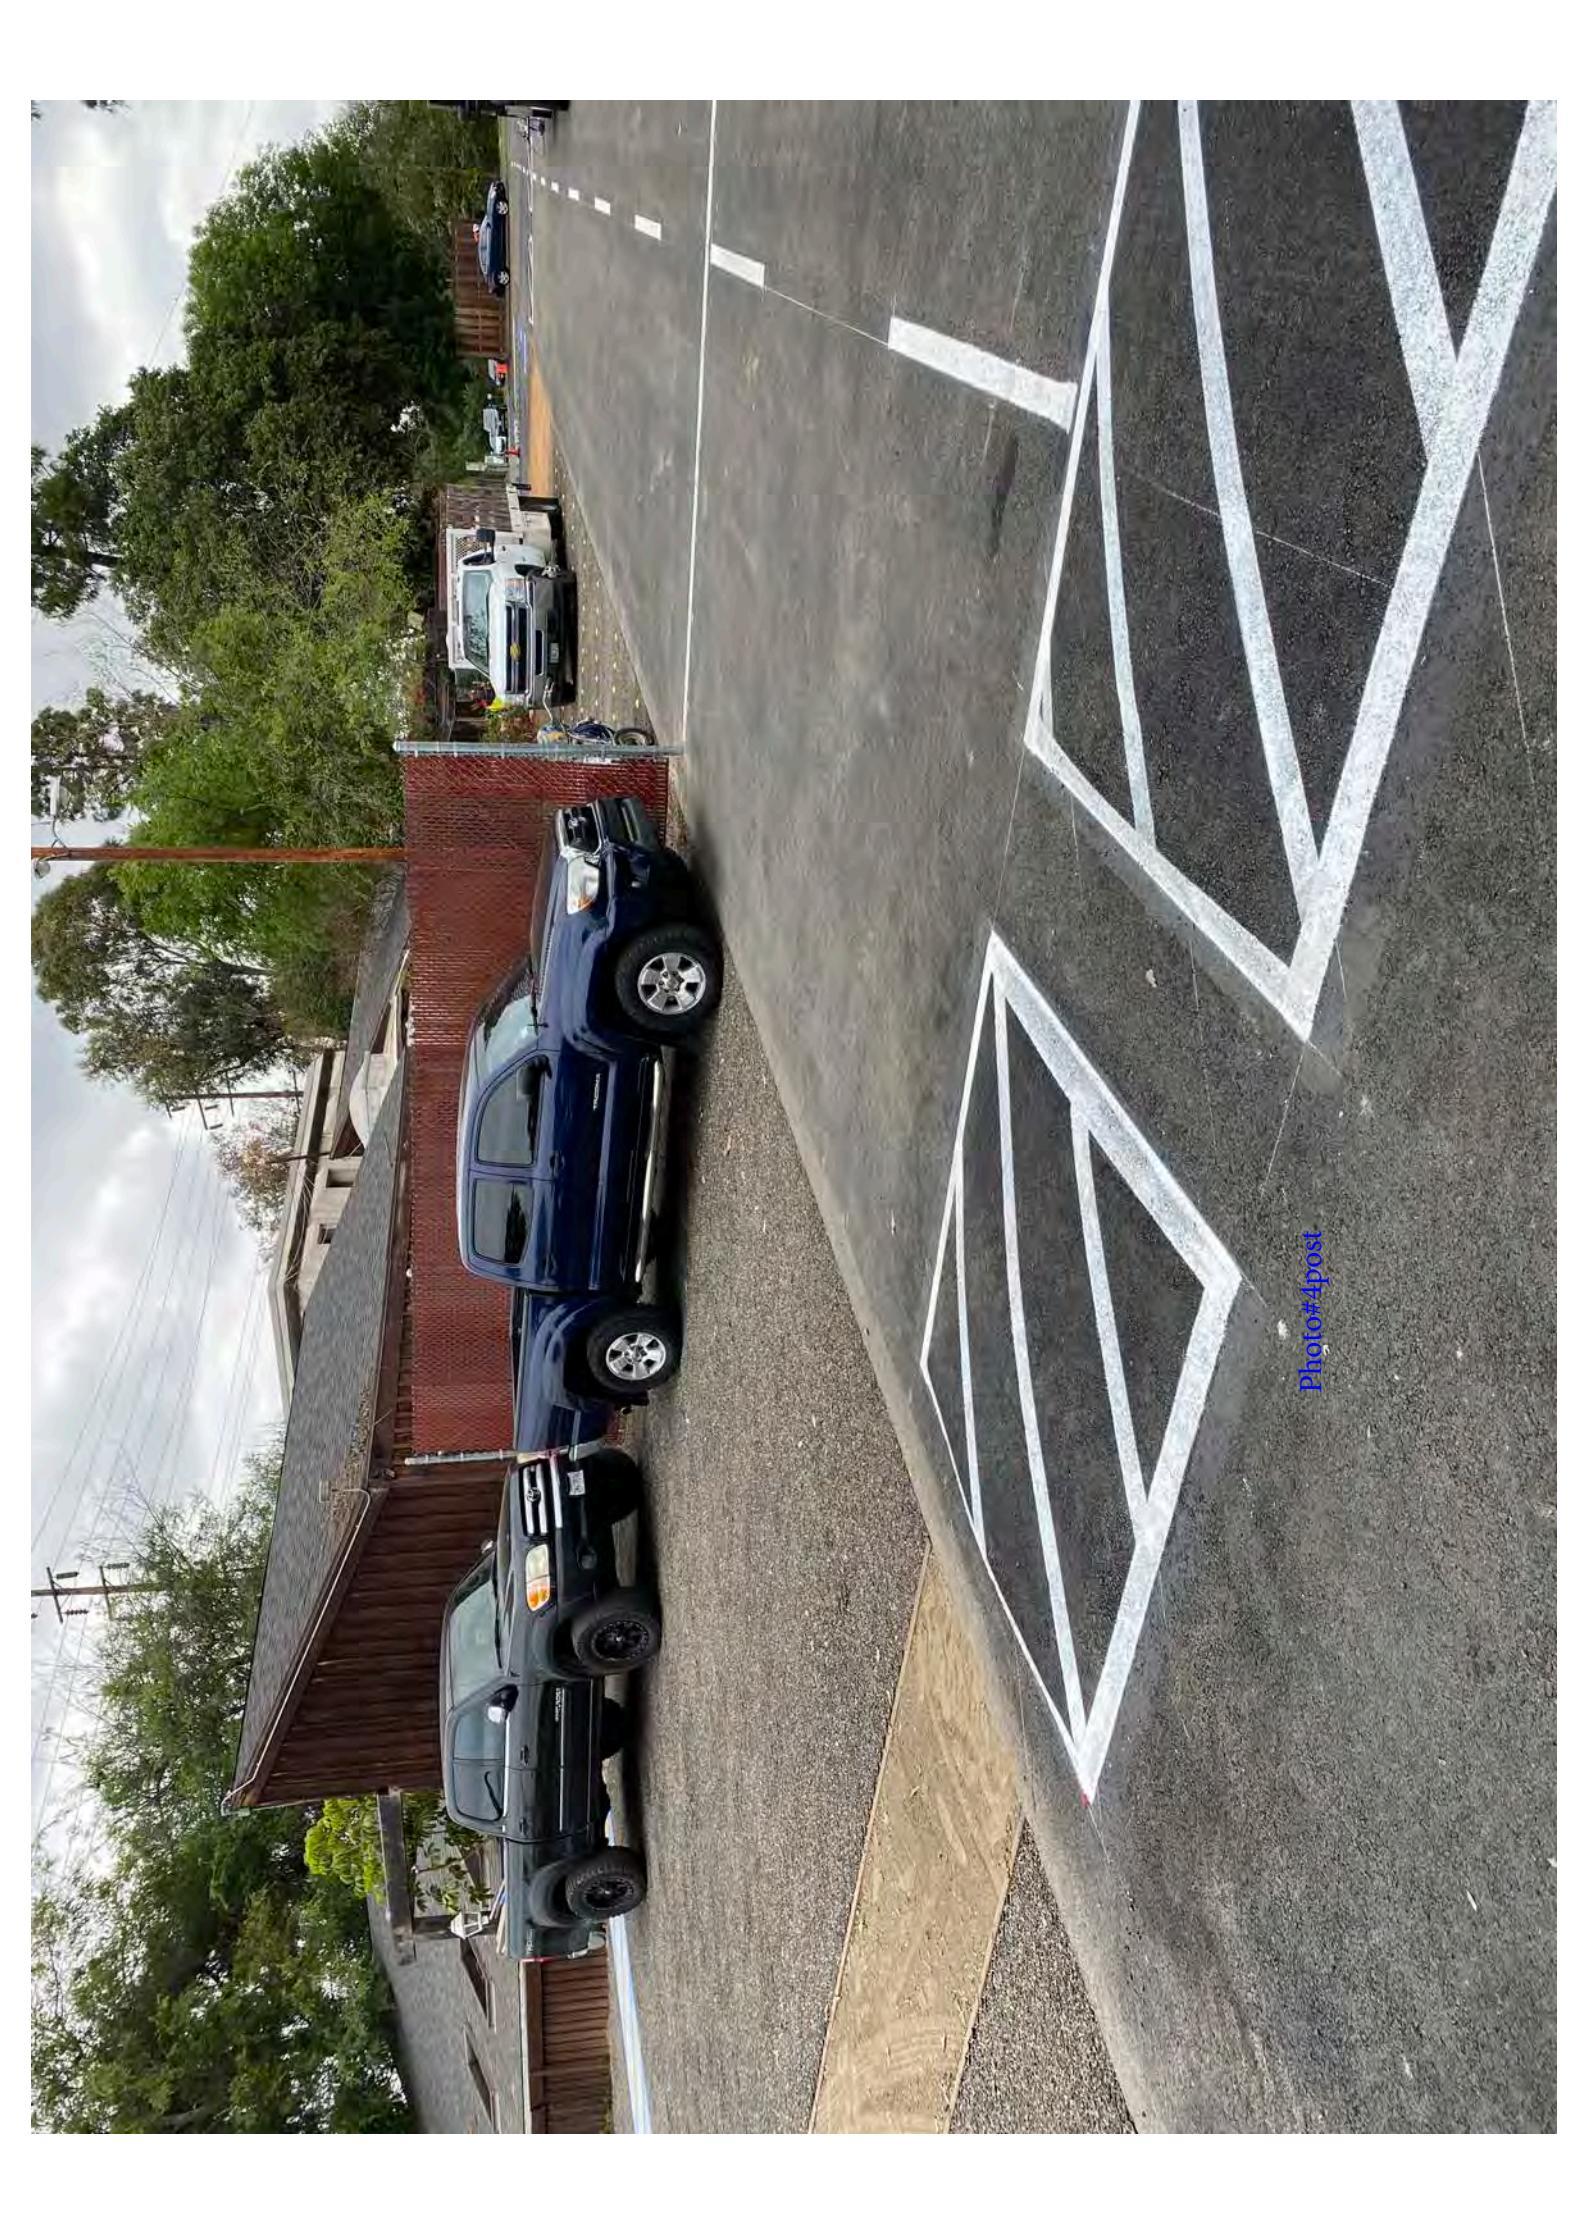
- Please provide photographic documentation with captions of pre-existing conditions and postproject conditions.
  See attached photos #1,#2, #3 and #4 of pre-existing and post conditions.
- 2. Please provide a figure showing the completed stormwater related project components and where they were installed/constructed within the project site.
  - See attached Construction Documents A2.0 & C1.40
- 2. How will your organization sustain and maintain this project in whole or in part now that POLB grant funding has been expended?

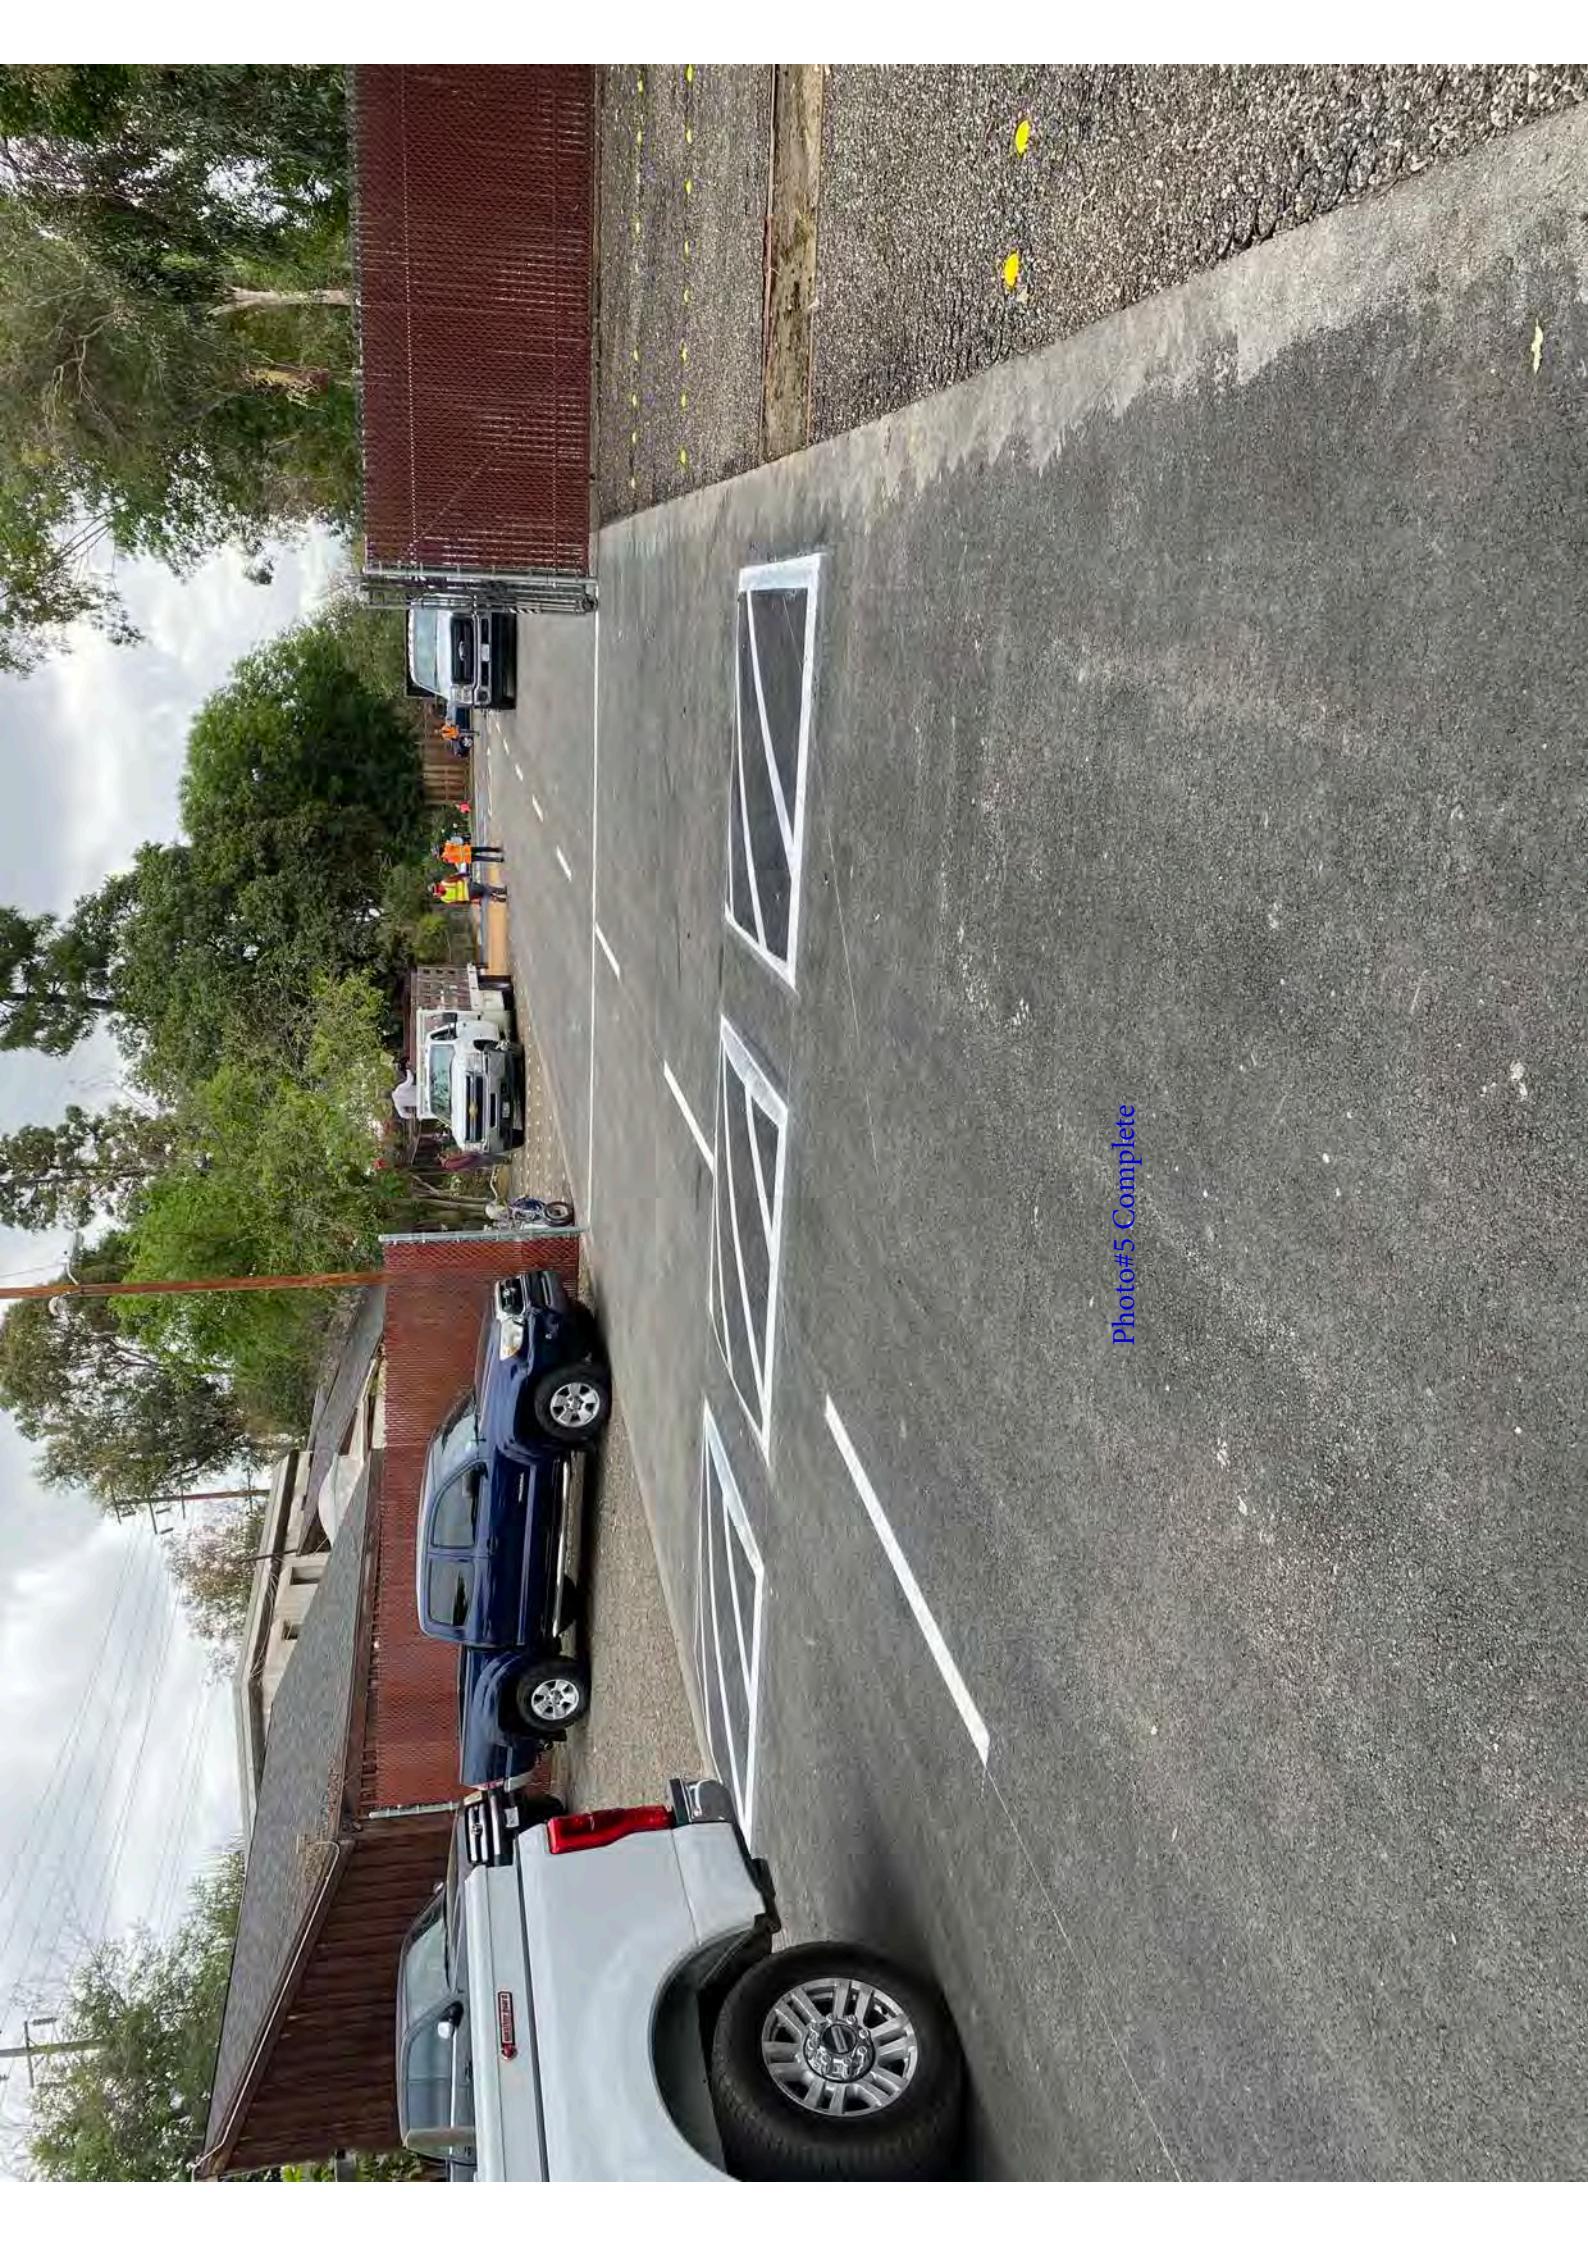
The use of this innovative permeable parking surface not only converted impermeable parking surface to permeable parking surface but by its unique look has also experientially and aesthetically improved one's perception of the venue. See attached photo #5 of finished parking.
